# Corrosive Resistant Application

**Hartzell Equipment:** Model S41P0-242FA100FGFMP3

## Exhausting Hydrogen Sulphide from Waste Water Treatment Building

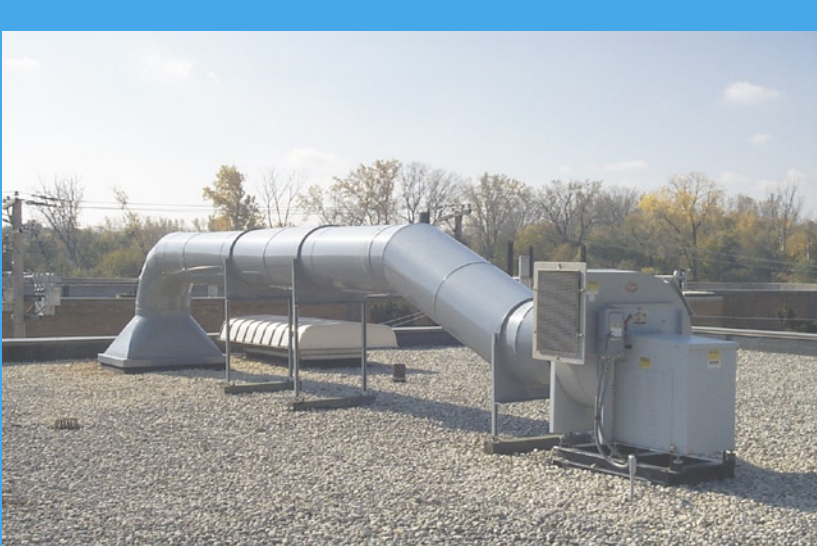
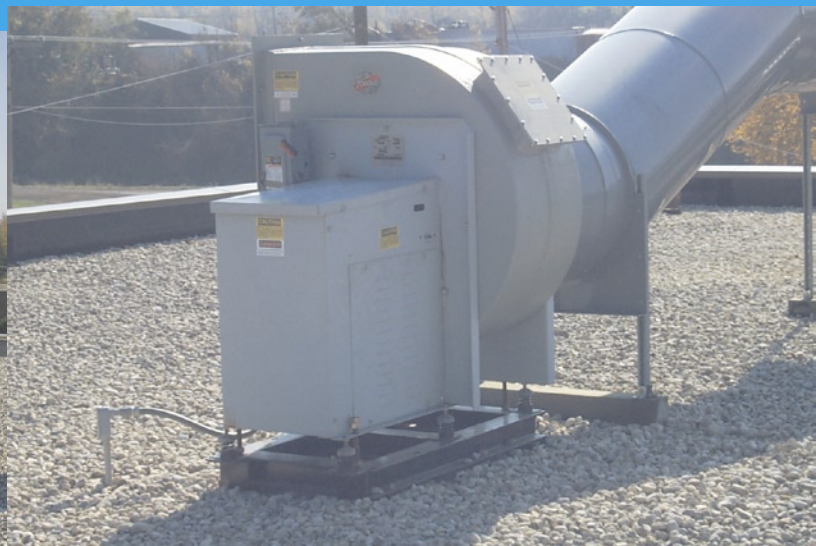
We decided to use a Hartzell Fan Series 41 Fiberglass Backward Curved Centrifugal located outside of the space in conjunction with PVC ductwork to solve the problem.
